Manhole Inspection Summary

Manhole # S17Y__017MH

Inspection ☐ Is Incomplete Rating: **3) Fair**

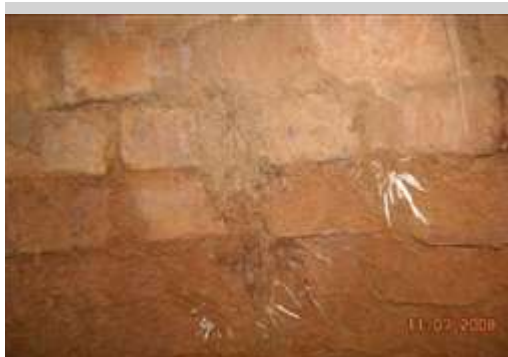
Defect 4

Condition: ☐ Sound ☐ Cracked ☒ **Root Intrusion** ☐ Loose Brick ☒ **Deteriorated**

ROOT INTRUSION @ BARREL WALL

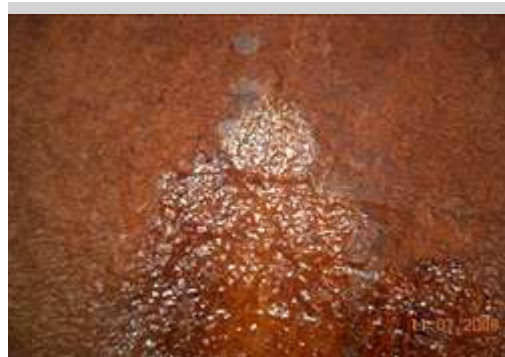
Defect 3

Infiltration: ☐ None ☐ Joint ☐ Cracks ☐ Mortar ☐ Roots ☒ **Wall**

INFILTRATION @ BARREL WALL

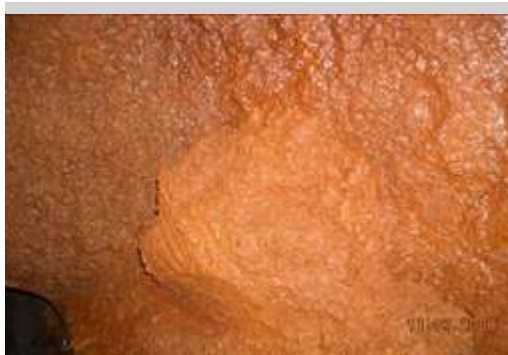
Defect 2

DETERIORATION/ENCRUSTATION OF
BARREL WALL

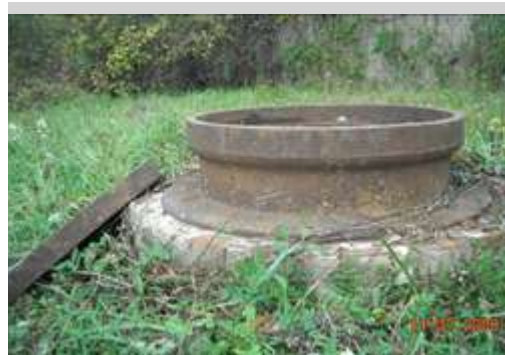
Defect 1

Comments **LOCATED JUST OUTSIDE THE PROPERTY FENCE FOR ANDERSON INDUSTRIAL CONTRACTORS. FRAME IS NOT ATTACHED TO STRUCTURE.**

FRAME ABOVE GRADE

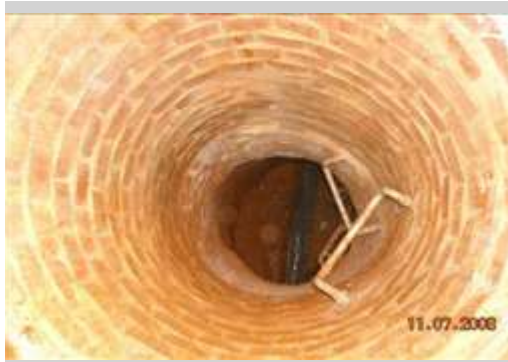
Defect

Condition: ☐ Sound ☐ Cracked ☐ Root Intrusion ☐ Deteriorated ☐ Leaks ☒ **Debris**

Bench Debris

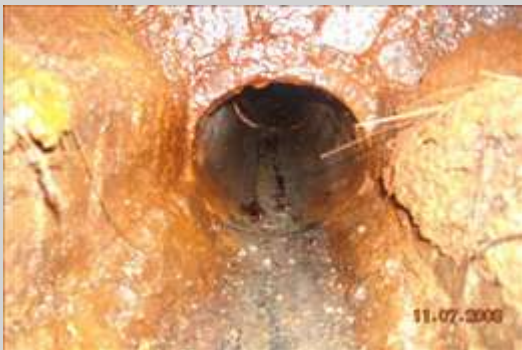
12 O'Clock Outflow

Pipe Height: **8.4** (in.) Rod and Bar (Angled)
Pipe Material: **Clay** ☐ Pipe Lined
Invert Depth: **15.39** (ft.) Flow Characteristics: **Slow**
Deposits: ☒ None ☐ Mud ☐ Sludge ☐ Debris ☐ Grease
Silt Depth: **0** (in.) Deposits Extent:
Infiltration: **None** Pipe Seal Cond: **Sound**

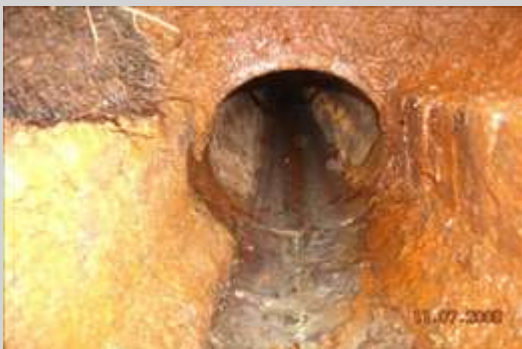
6 O'Clock Inflow

Pipe Height: **8.4** (in.) Rod and Bar (Angled)
Pipe Material: **Clay** ☐ Pipe Lined
Invert Depth: **14.90** (ft.) Flow Characteristics: **Slow**
Deposits: ☒ None ☐ Mud ☐ Sludge ☐ Debris ☐ Grease
Silt Depth: **0** (in.) Deposits Extent:
Infiltration: **None** Pipe Seal Cond: **Sound**
